HOW TO KEEP A TWIN CAM FROM BURNING PISTONS (Bill Spohn)

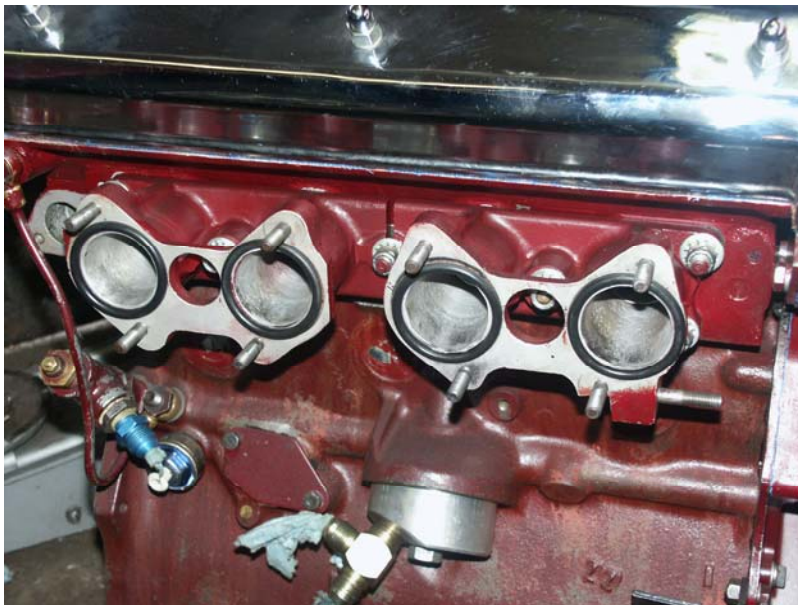
Here is a picture of an O ring mount (on a Weber manifold, but the principal is the same).

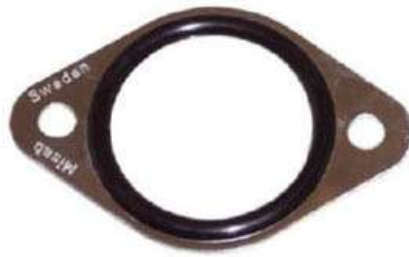
Look for a soft mount kit for one DCOE carb to suit both SUs on a Twin Cam. (Weber #99005.110, Warnford #301-110). The pictures below come from www.merlinmotorsport.co.uk for example.

They need minor modification from the Weber bolt pattern, to fit SUs. This is easily done by laying one of the 4 stud SU gaskets on top of the Weber gasket and marking where you need to move the holes, and then easing them with a suitable rat tailed file, Dremel or wad punch. Obviously the two holes will fit over only one diagonal pair of the SU manifold studs.

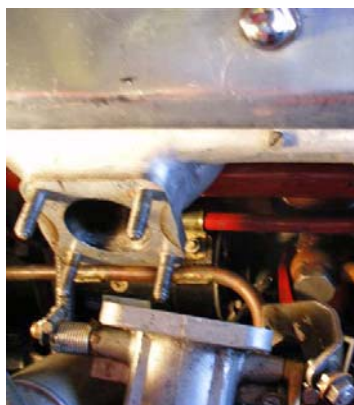
You can see in the picture the pattern of the stock Twin Cam carb gasket.

You use Thackery washers – double wound spring washers that look like this:

on all the studs, and you just tighten them until a feeler gauge of 0.035”- 0.040” can fit between the coils. You then need to lock the nuts in place and that means using some form of lock nut. As the thickness of the new gasket uses up some of the available stud length, conventional locknuts with a nylon insert on top may not tighten down far enough to engage the nylon. This can be overcome by fitting slightly longer studs, or by using a different form of locknut – either the ones that look like a normal nut with a small nylon insert in the side, or all steel nuts meant for high heat use that have a slightly ovalled section (be careful with these as they may grab the stud so tightly that the next time you undo them the stud comes with them).

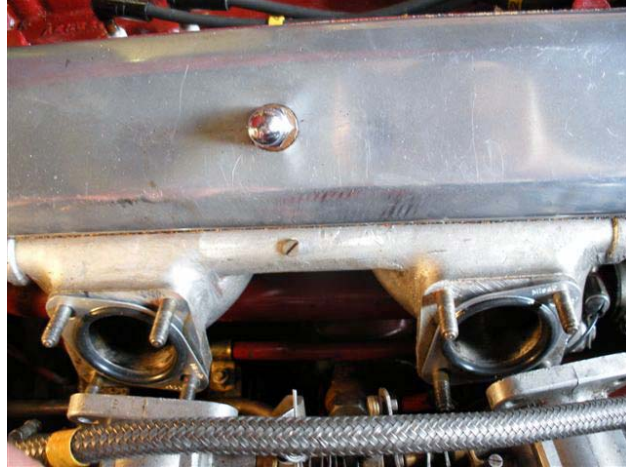
Here is the new modified gasket sitting in place:

The amount that the holes need to be eased is quite small. The carbs are then fitted and the Thackery washers are used:

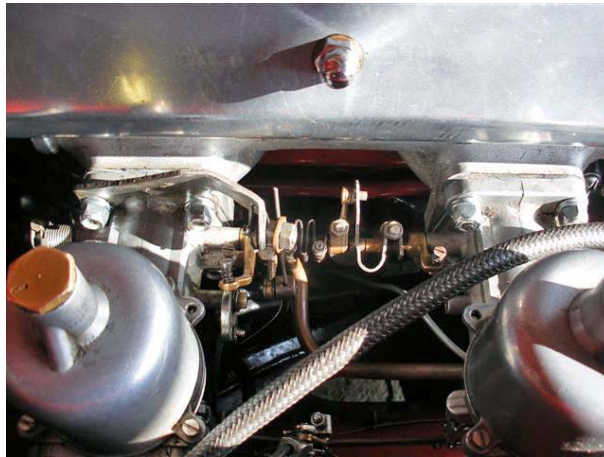
The appearance is altered only by adding a small gap between manifold and carb. The nuts look like they are tightened about the right amount (you can double check by grabbing a carb on the outside and trying to move it up and down – it should have a small amount of available wiggle). It also looks like David will be looking for slightly longer studs or different nuts as the nylon portion doesn't appear to be biting. Racers will also pin or lock-wire these fasteners, of course, but the nylon locknuts will probably be sufficient for street users.
