## FITTING MGB FRONT SUSPENSION TO AN MGA

Having said that, I found myself with a problem in my current project, transplanting a GM V6 into my rebodied MGA 1500. <http://www.rhodo.citymax.com/Jamaican.html>

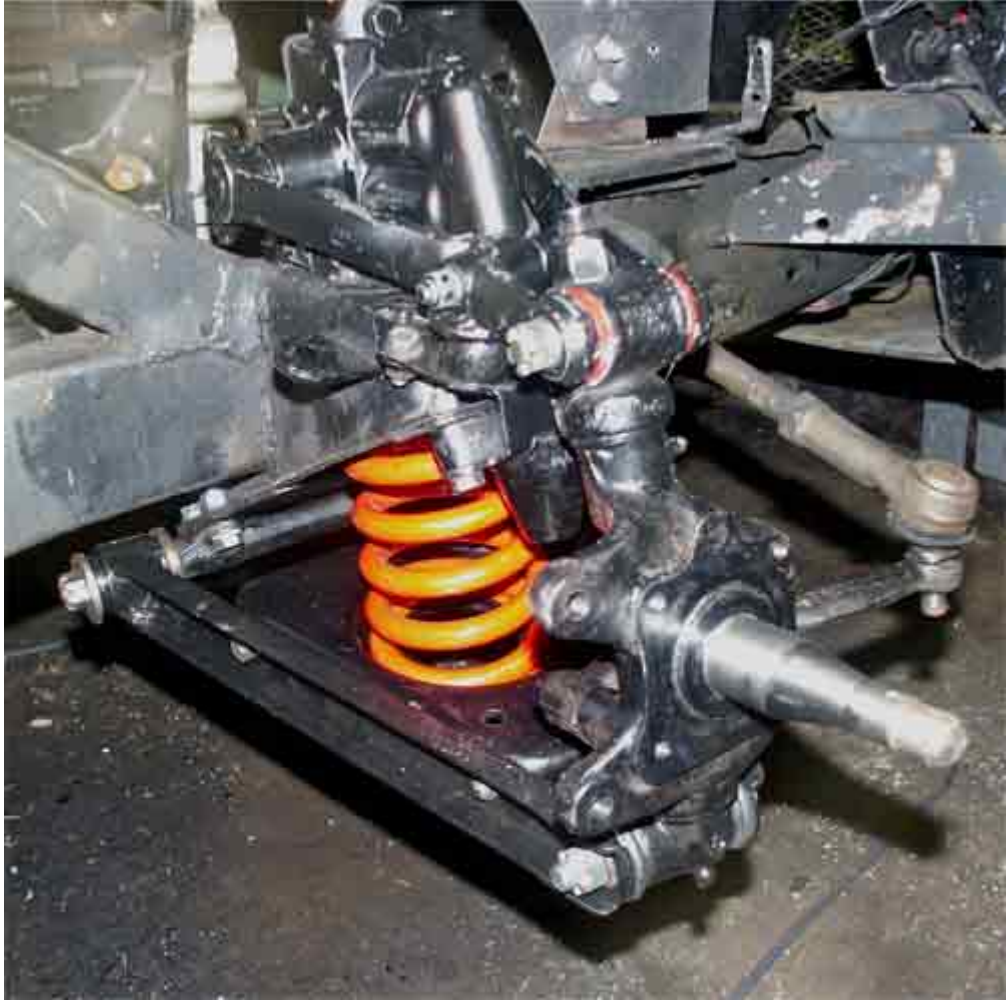
Problem #2 – MGB steering arms are different than MGA. They windup with the tie rod end bolt hole closer to the center of the car than the MGA does. Shortening the steering rack in the middle to suit the relocated steering arm ends is expensive, but is the proper way to do this. Hacking a bit off each one is a pain and doesn't solve the potential for bump steer. One potentially easy way out that I tried was to fit the longer negative camber A arms that are readily available for the MGB, so that the tie rods ends need not be shortened. Unfortunately the MGB geometry is just different enough that this results in excessive (4 deg.) negative camber. Final solution – run a 5/8" die up each tie rod end to extend the threading as close to the two flats where you hold the tie rod for adjustment as you can, and saw off about 1/2" from the end. Best to do this while the die is still on it so you can clean the threads as it comes off again. Then take the tie rod end and cut another 1/2 - 3/4" off the inner threaded portion to ensure that you will be able to adjust enough to pull the tie rod ends in without them bottoming in the tie rod end.. Result is around 1.5 deg. negative camber, right where you want it.
